Manhole Inspection Summary

Manhole # S23K__061MH

Insp Date: **6/10/08 2:40 PM**

Location Address: **SStricker St**

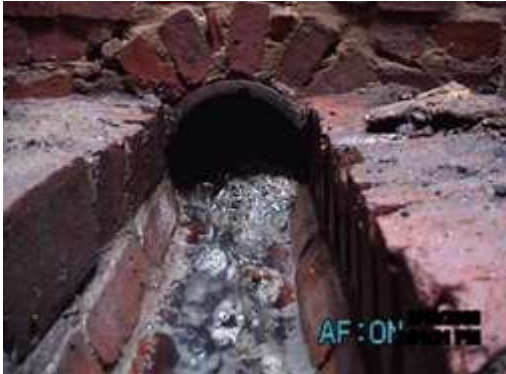
Micellaneous

debris in channel

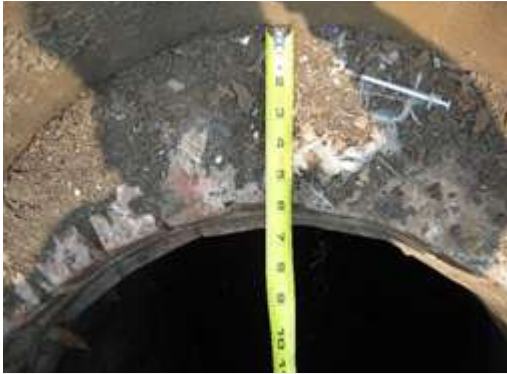
Defect 6

Offset: **6** (in.)

6 inch offset

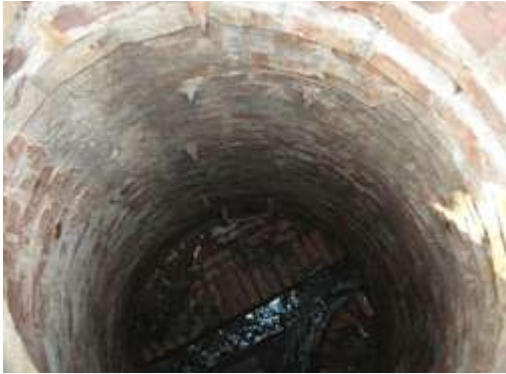
Defect 5

Count: **6** Missing: **5** ☒ **Corroded**

5 broken rungs

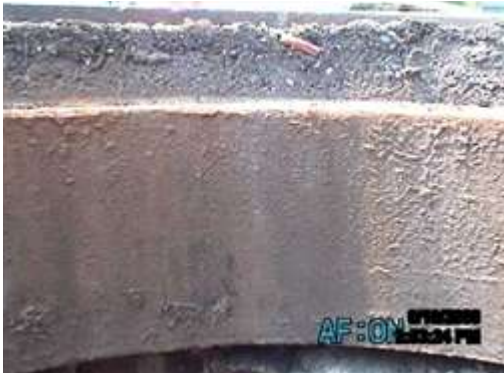
Defect 4

Condition: ☐ Sound ☐ Cracked ☒ **Leaks**

infiltration frame-lid

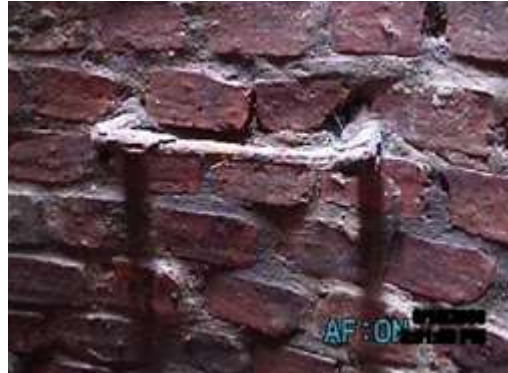
Defect 3

corrode rung

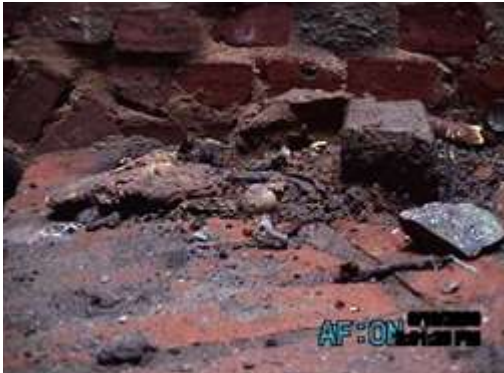
Defect 1

Condition: ☐ Sound ☐ Cracked ☐ Root Intrusion ☐ Deteriorated ☐ Leaks ☒ **Debris**

DEBRIS ON BENCH

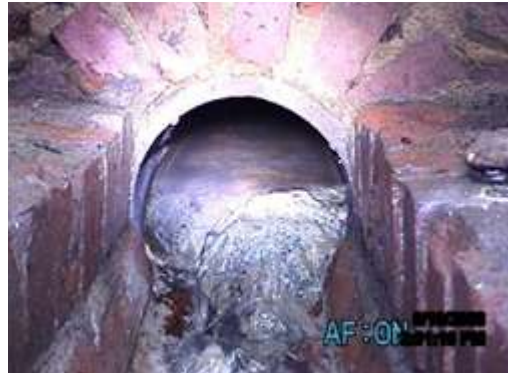
Defect 7

heavy debris in 6:00 connection

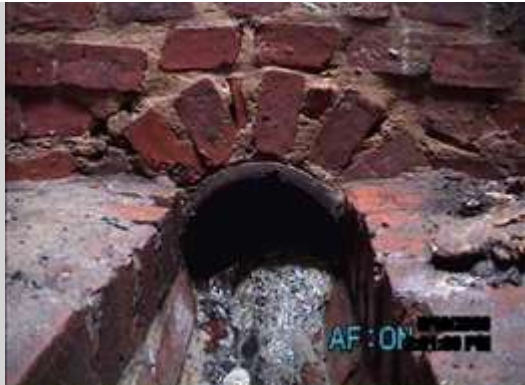
6 O'Clock Inflow

Deposits: ☐ None ☐ Mud ☐ Sludge ☒ **Debris** ☐ Grease

Silt Depth: **5** (in.) Deposits Extent: **Heavy**
